Schroon Lake Invasive Species Reconnaissance 2015
Robert Bombard & Nicholas Rowell
31 B Depalo Lane
Queensbury, NY 12804
(518)926-8376 or (518)321-5024

The 2015 Eurasian Watermilfoil (EWM) survey of Schroon Lake was done at the behest of the Schroon Lake Association. The EWM survey parameters included us snorkeling and diving approximately 10ft apart throughout the littoral zone of the chosen sites. The survey consisted of snorkeling the shallow areas of plant growth to scuba diving to the deepest point of plant growth. Throughout each site surveyed, the EWM plant locations were mapped using a GPS. After each survey day, a report and map of GPS EWM locations were sent to both the SLA and AIM Inc. The sites surveyed were chosen through a combination of the SLA Board Members, the Lake Manager suggestions, areas with extensive littoral zones, high nutrients areas at tributary outlets and previously known locations of EWM populations. The following is a compilation of our daily reports, GPS EWM location maps and site descriptions.

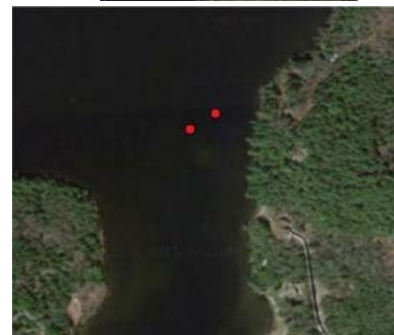
July 11th EWM Survey

North end of Clark Island east shore- Two GPS points were collected in this location with 50-75 EWM plants located between the points. Both points are located within the buoy-line and the northeast point is approximately 100 meters off the east shore.

We finished up the day just south of the halfway point of Clark Island and no additional plants were found.

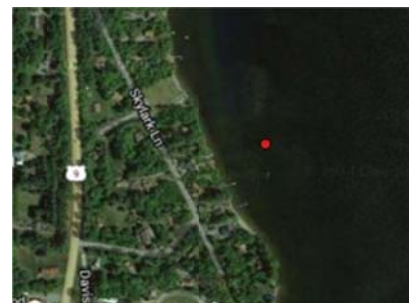
July 26th EWM Survey

Skylark Beach Area North & South- At the GPS point mapped is a log pile with approximately 100 EWM plants. The EWM plants are young, single stem plants with the majority of the plants being 1-2ft tall and the max height around 4ft. Scattered EWM plants were found from the GPS point extending 100 meters north and located mainly in 10ft of water. The area around Skylark Beach has a very large littoral zone that ends around 13ft deep from our observation. The native plants are diverse and robust in this area.

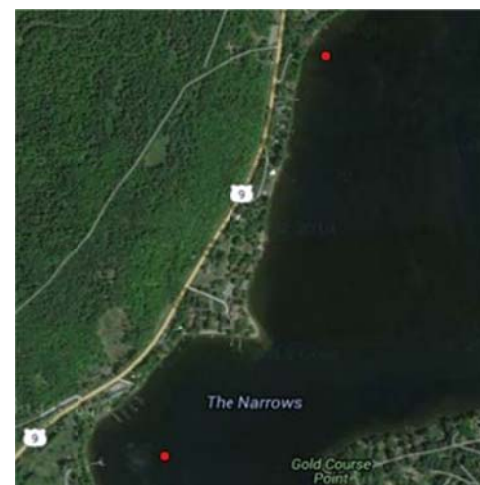
August 15th EWM Survey

Bay South of Edge Water – While surveying the bay we found EWM plants widely scattered throughout the bay. At the mapped GPS point is approximately 25 EWM plants in 8-10ft of water and from our observation, the EWM plants are tall but distressed. We also want to note that two distinct native milfoils were also found throughout the bay in more abundance. Some of the observed natives were tall plants as well. At the time of this survey, there was a considerable phytoplankton bloom. This bay is also home to a very large friendly bass that accompanied us during our survey.

North of Edge Water to Sandy Point– At the northern GPS point on

the attached map, we observed scattered EWM plants in 6-10ft of water, approximately 2-3ft tall and mostly single stem plants.

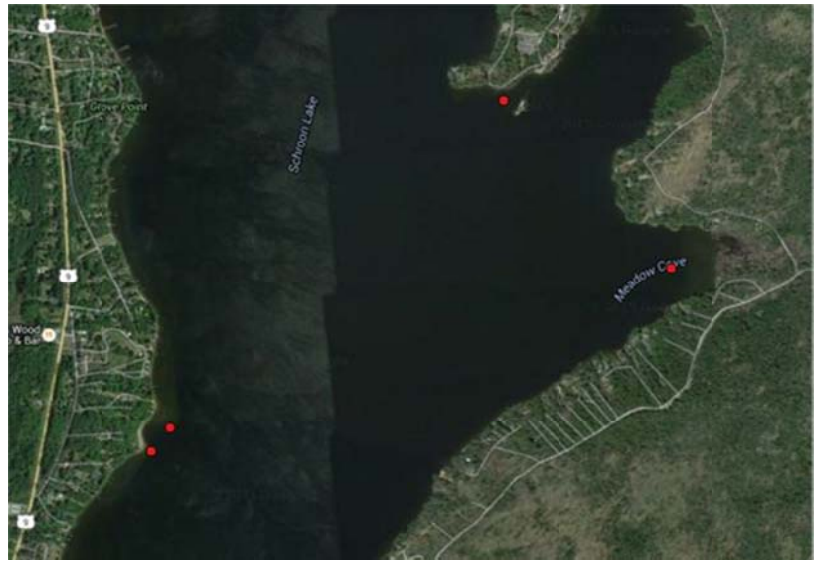
August 22nd EWM Survey

Sandy Point- A few hundred widely scattered EWM plants found between the two GPS mapped points in Sandy Point. The EWM plants were found in 2-14ft depth of water and the majority of the plants were single stem. There are also very robust native plants in this area as well. We surveyed 300 meters north of the northern buoy and found no EWM plants.

Meadow Cove- We found very widely scattered single stem 2-3ft tall EWM plants and took two dozen found throughout the cove. The marker bottle is still in the location of the small population of EWM plants. The majority

of the EMW plants were observed in 6-10ft of water. The cove also has a robust population of elodea.

South Clark Island- We observed only 6 EWM plants in this area and all were taken. The EWM plants were all single stem 2ft tall plants, found in 6-8ft of water and were not well rooted. We would also like to note that a fair amount of cans, bottles and clothing were also found in this area.

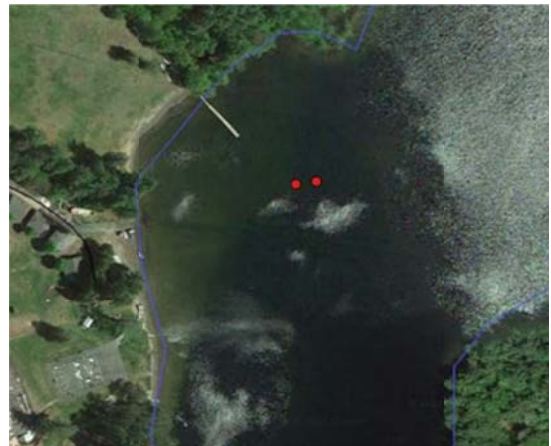
August 29th EWM Survey

West of Brill Island- We surveyed the bay west of Brill Island along a very steep wall directly off the west shore. Between the two GPS points we found 50-100 EWM plants in 12ft of water. The EWM plants are multi-stemmed and approximately 10ft tall. From our observation the EWM plants are concentrated to a 20x50ft area. We then surveyed from Brill Island to Eagle Point and to the bay south of Taylor Point. No other EWM plants were found. The bay south of Taylor point has an extensive littoral zone and no milfoils of any kind were observed.

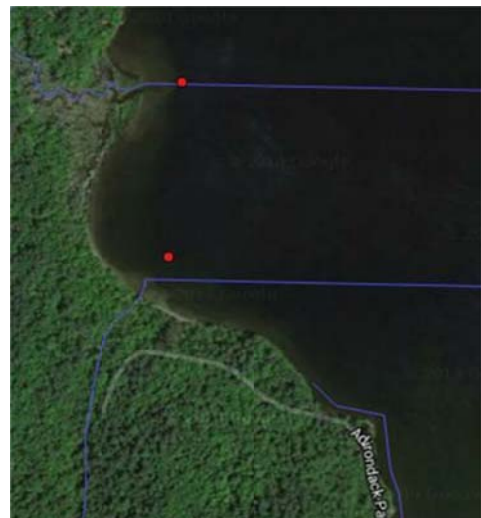
August 30th EWM Survey

Bay Between Moffit & Acker Brook- The southern GPS point is at the mouth of Moffit Brook where 12 single stem EWM plants, 1-3ft tall were taken and a small patch of multi-stem 5-6ft tall EWM plants were observed. The EWM plants were widely scattered among native milfoils. The northern GPS point is located at the mouth of Acker Brook where a single EWM plant was taken. The mouth of Acker Brook has very lush, diverse growth and should be watched in the following years. We continued to survey north of Acker Brook and no other EWM plants were observed.

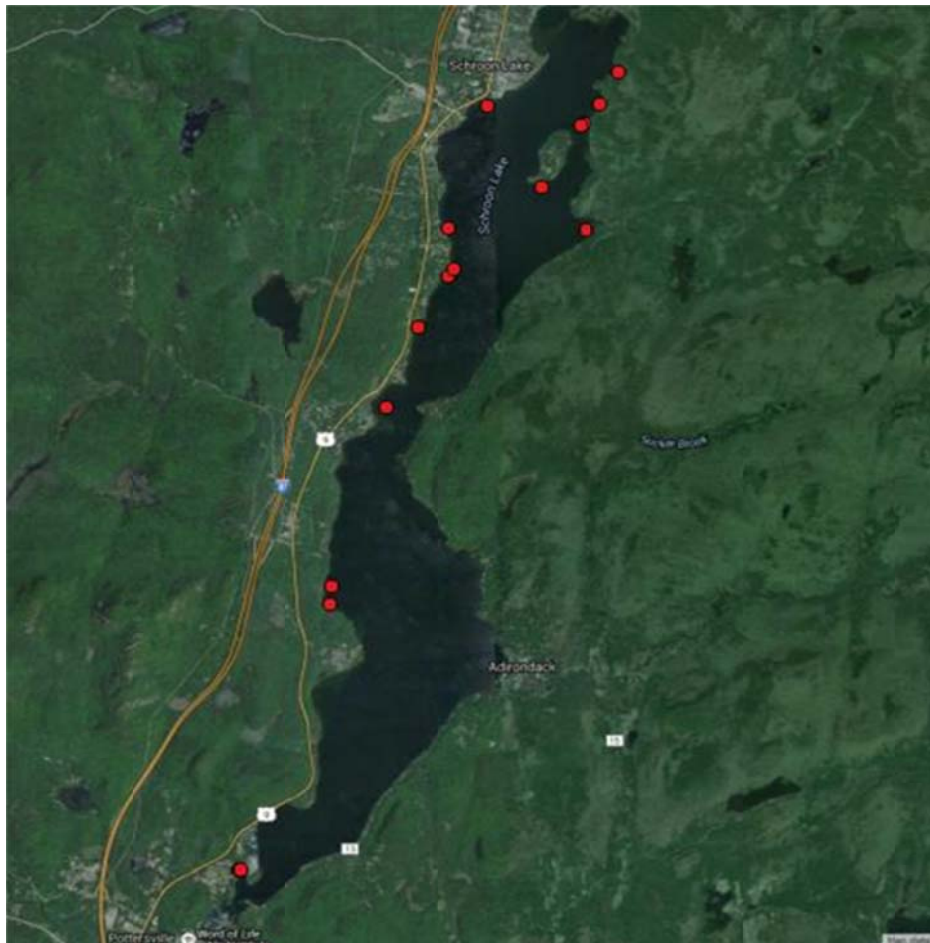
Schroon Lake EWM Survey

From our overall observation, the EWM plants in Schroon Lake are widely scattered, low density populations throughout most of the locations surveyed in 2015. The majority of the EWM populations observed during the survey were young, single stem, new growth plants. In the rare occasion where mature multistem plants were observed, the EWM plants were contained in small areas

approximately 10x20ft and would not be considered a bed. During the survey, we covered approximately 25,700 linear feet of shoreline, equaling 4.8 miles. The actual distance covered was approximately three to four times that distance due to the width of the littoral zones in each location require multiple passes to cover the area. Throughout the summer we surveyed for 8 days totaling 42 hours and 14 EWM locations were discovered and mapped with a GPS. It is recommended that any areas of lush native growth continue to be surveyed where nutrients may be high. Three quarters of the east shore still need to be surveyed, especially near any tributaries. Continued vigilance is always the best war against invasive species. Also, the continued use and success of the scout program and the watchfulness of lake property owners to communicate possible EWM sightings to project managers will ensure the continued success of the invasive battle.
