Eurasian Watermilfoil Management
Report
Schroon Lake
July 17 - July 20, 2017

Work Summary for the period 7/17/2017 - 7/20/2017

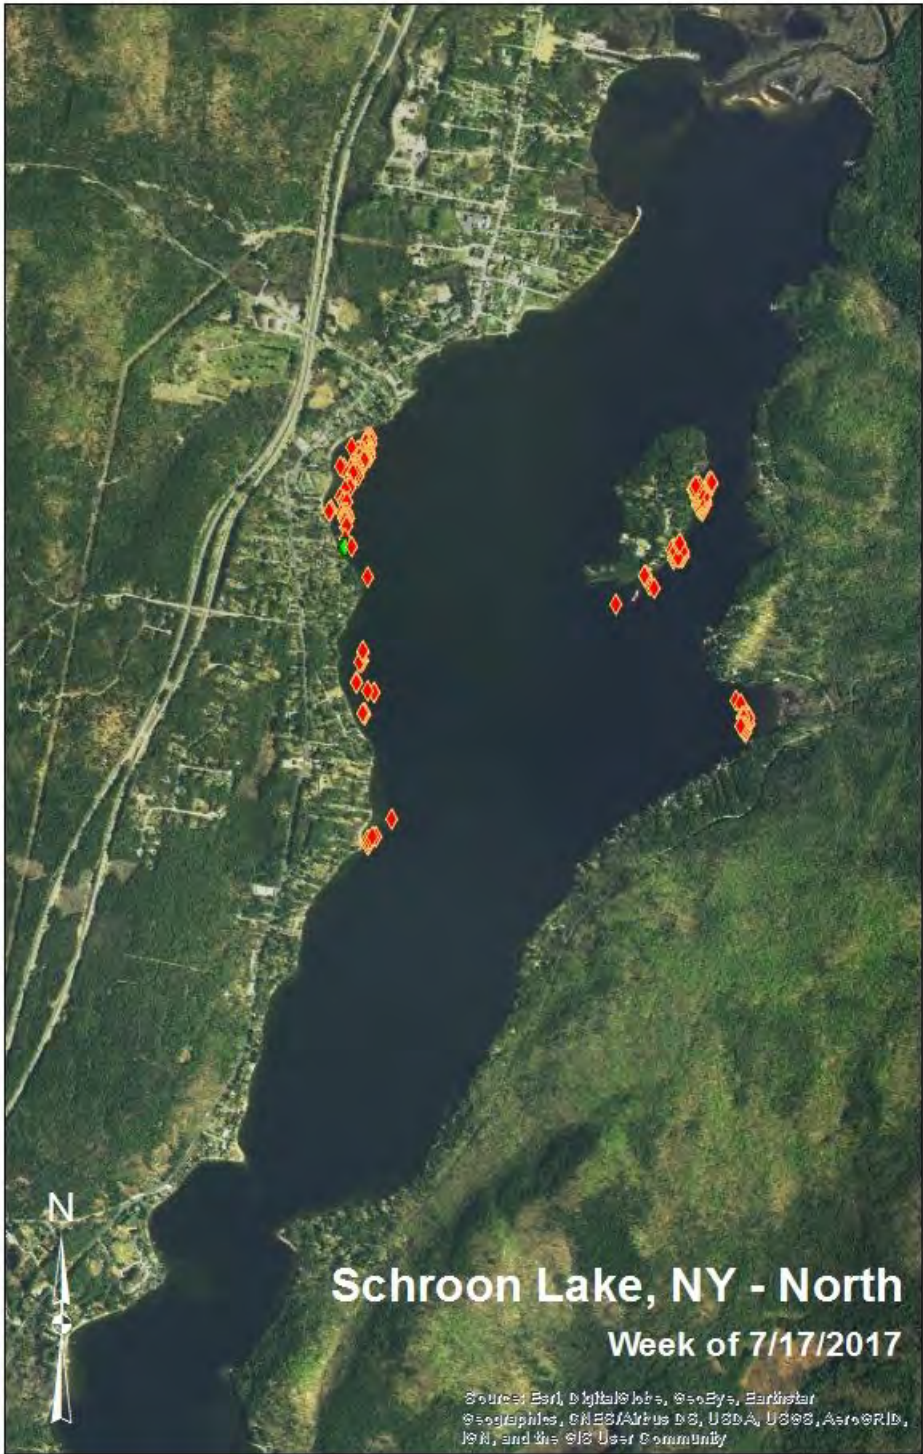
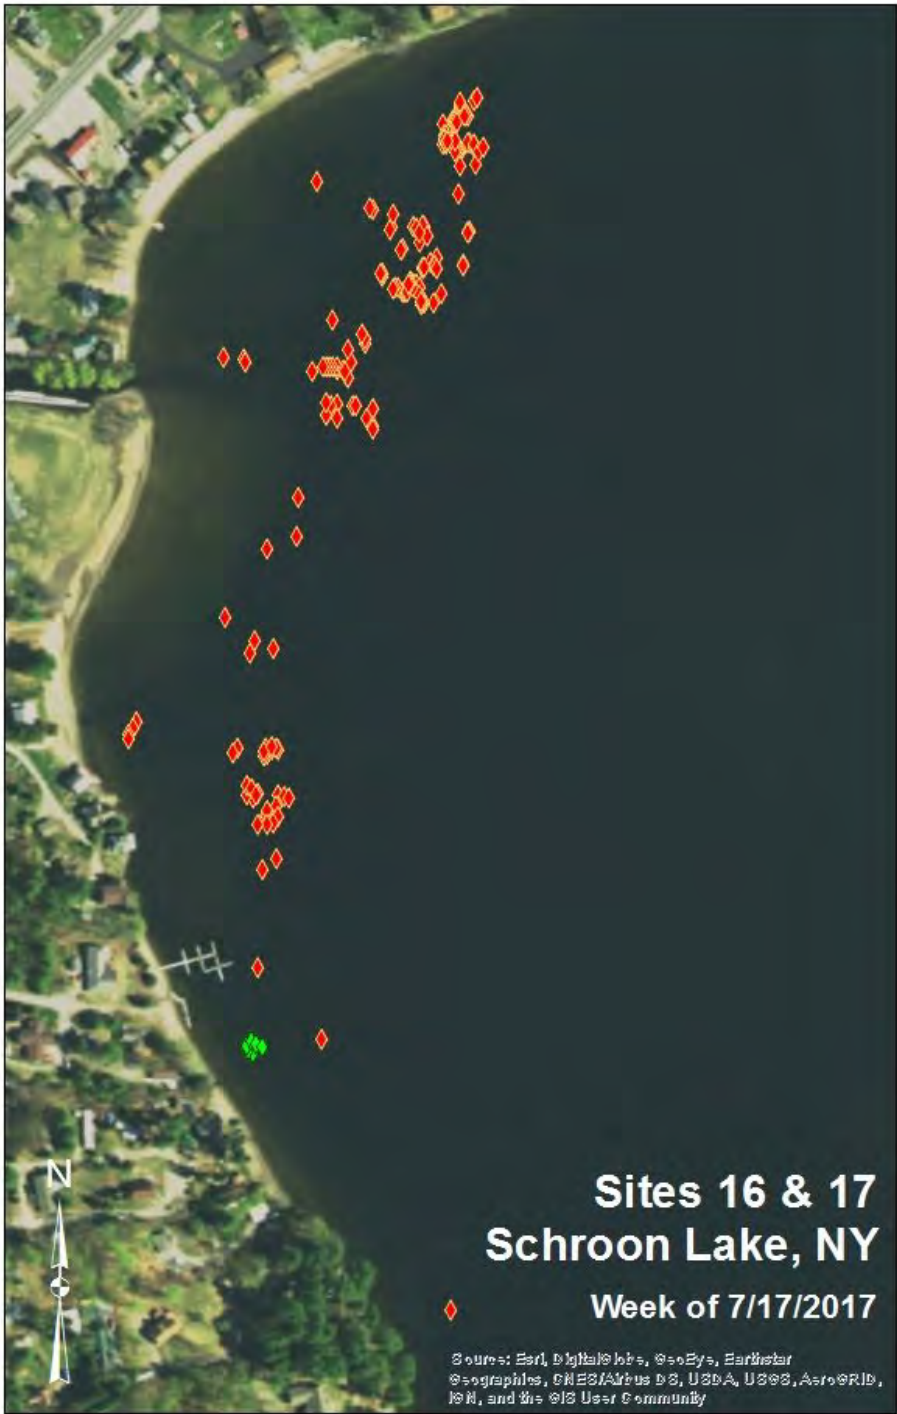
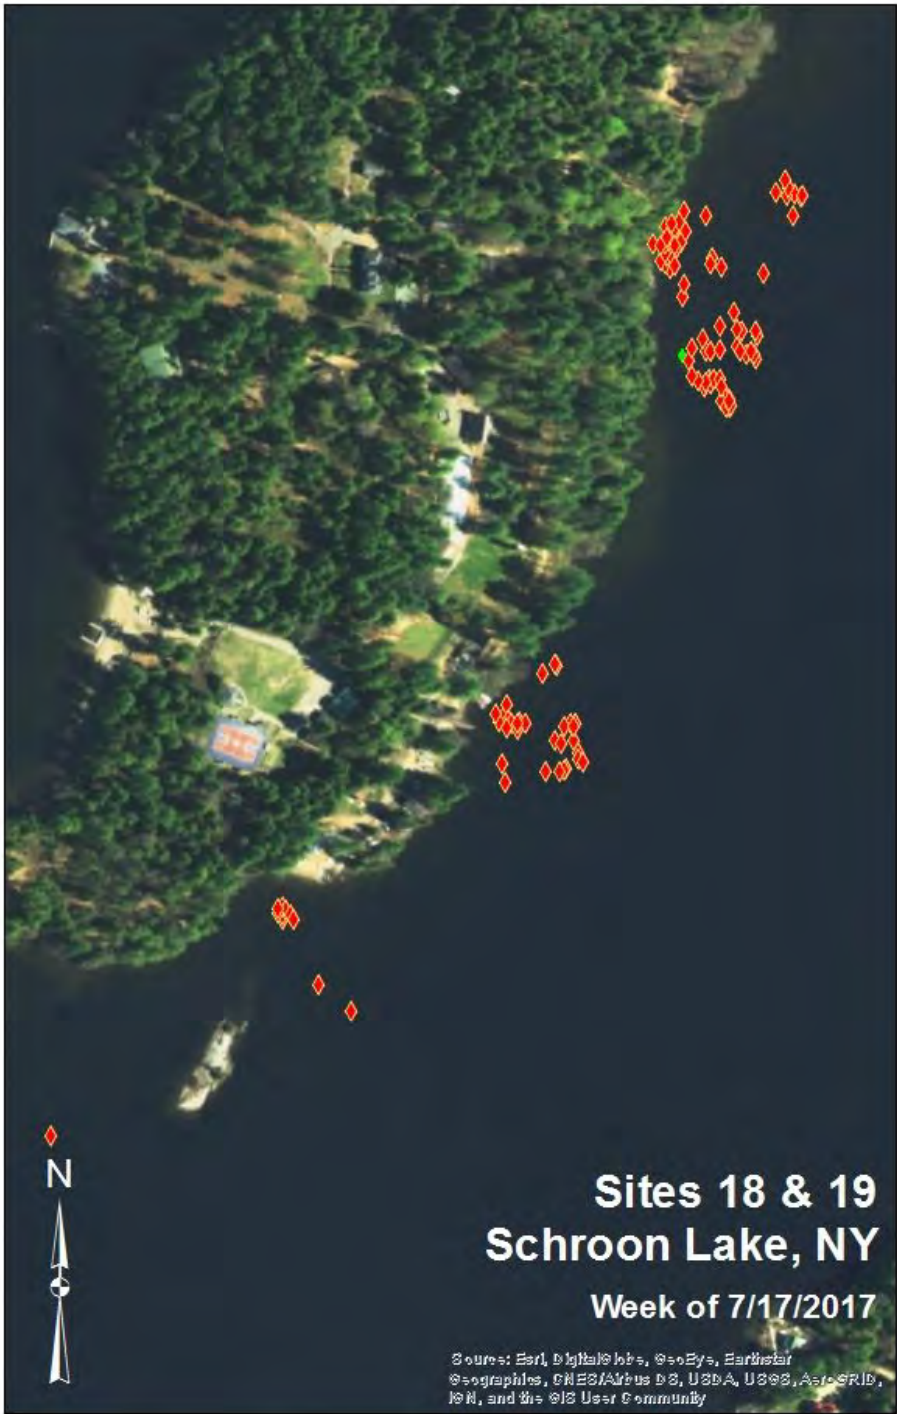
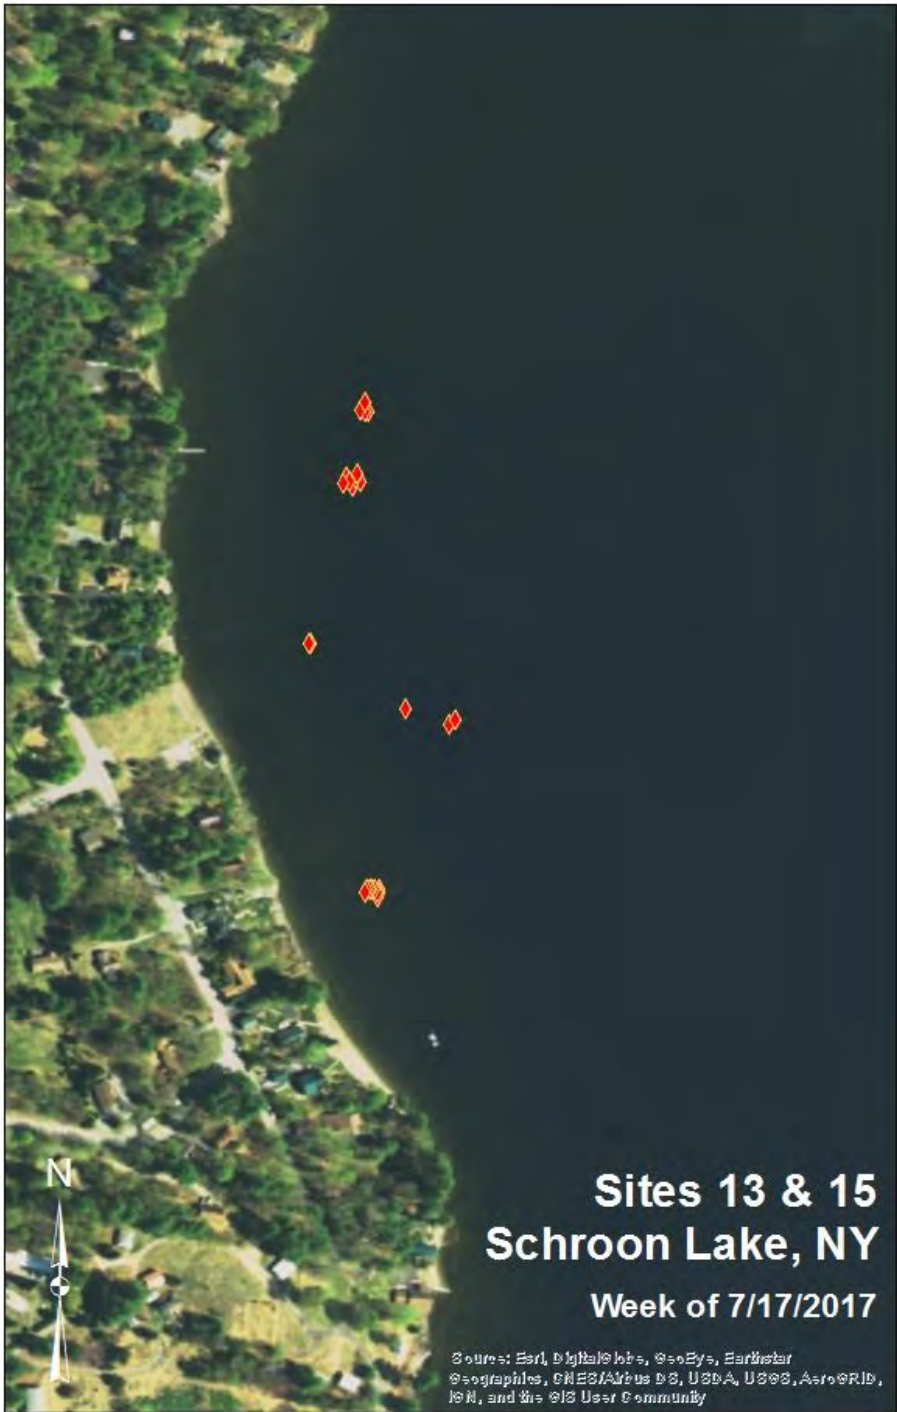
***Curly-leaf Pondweed denoted by Green GPS points on accompanying maps.**

3 bags of Eurasian Watermilfoil were harvested for a total of 75 lbs for the week. Recommendations-Sites which need to be checked again sooner than later include sites 18, 17, and 16. No dense patches were found but those sites had the most amount of EWM growing. Sites 19, 14, 15, 10, and 12 had the least amount of EWM found but they still need to be check periodically to ensure low EWM re-growth. Curly-leaf Pondweed was marked in green on the GPS. Those sites should be checked again soon as well to ensure no re-growth.
