Schroon Lake Invasive Species Reconnaissance 2017

The 2017 Eurasian Watermilfoil (EWM) survey of Schroon Lake is a continuation of our three year partnership with the Schroon Lake Association. The EWM survey parameters included us snorkeling and scuba diving approximately 10ft apart throughout the littoral zone of the chosen sites. The survey consisted of snorkeling the shallow areas of plant growth to scuba diving to the deepest point of plant growth. Throughout each site surveyed, the EWM plant locations were mapped using a GPS. After each survey day, a report and map of GPS EWM locations were sent to both the SLA and AIM Inc. The sites surveyed were chosen through a combination of the SLA Board Members, the Lake Manager suggestions, areas with extensive littoral zones, high nutrient areas at tributary outlets and a focus on sites not yet surveyed. The following is a compilation of our daily reports, GPS EWM location maps and site descriptions.

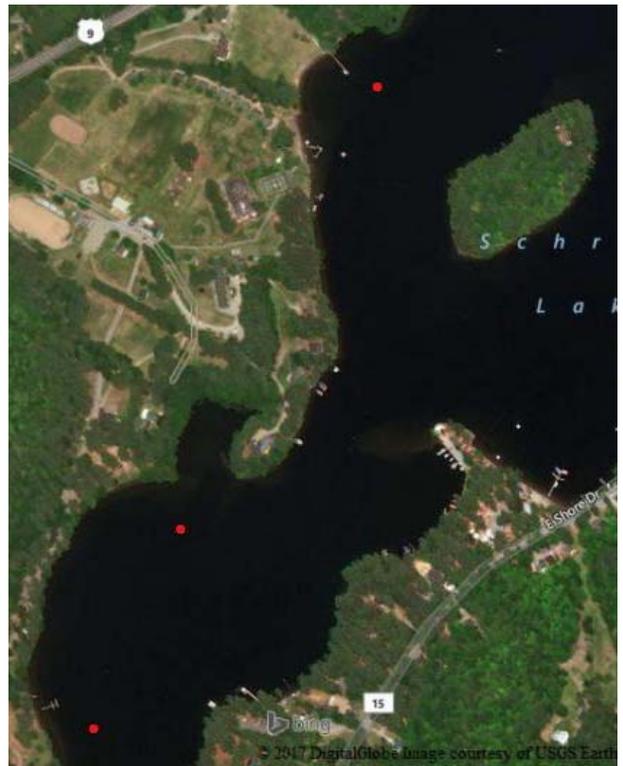
WOL Ranch- At the south mapped GPS point we observed moderately scattered EWM plants growing to the surface and the scouts have also marked this area with milfoil bottles. Additionally widely scattered EWM plants were observed north in a line to the wetland which is also a GPS mapped point. This area also has significant native plant growth and the water is very cloudy with very limited visibility. We also wanted to note that the 6" green PVC pipe coming from the shore of WOL has a disconnection.

Brill Island- At the GPS point west of Brill Island we checked a small known site from year one and observed approximately 25 widely scattered EWM plants in 8' depth.

Schroon Manor- We made a quick stop and observed three EWM plants on the backside of docks 12 & 13 with numerous native milfoil plants growing around the docks.

Six Loon Bay- We surveyed between Moffit and Acker Brook and at the mapped GPS points we observed 25+ EWM plants widely scattered.
