Schroon Lake Invasive Species Reconnaissance 2018

Robert Bombard & Nicholas Rowell

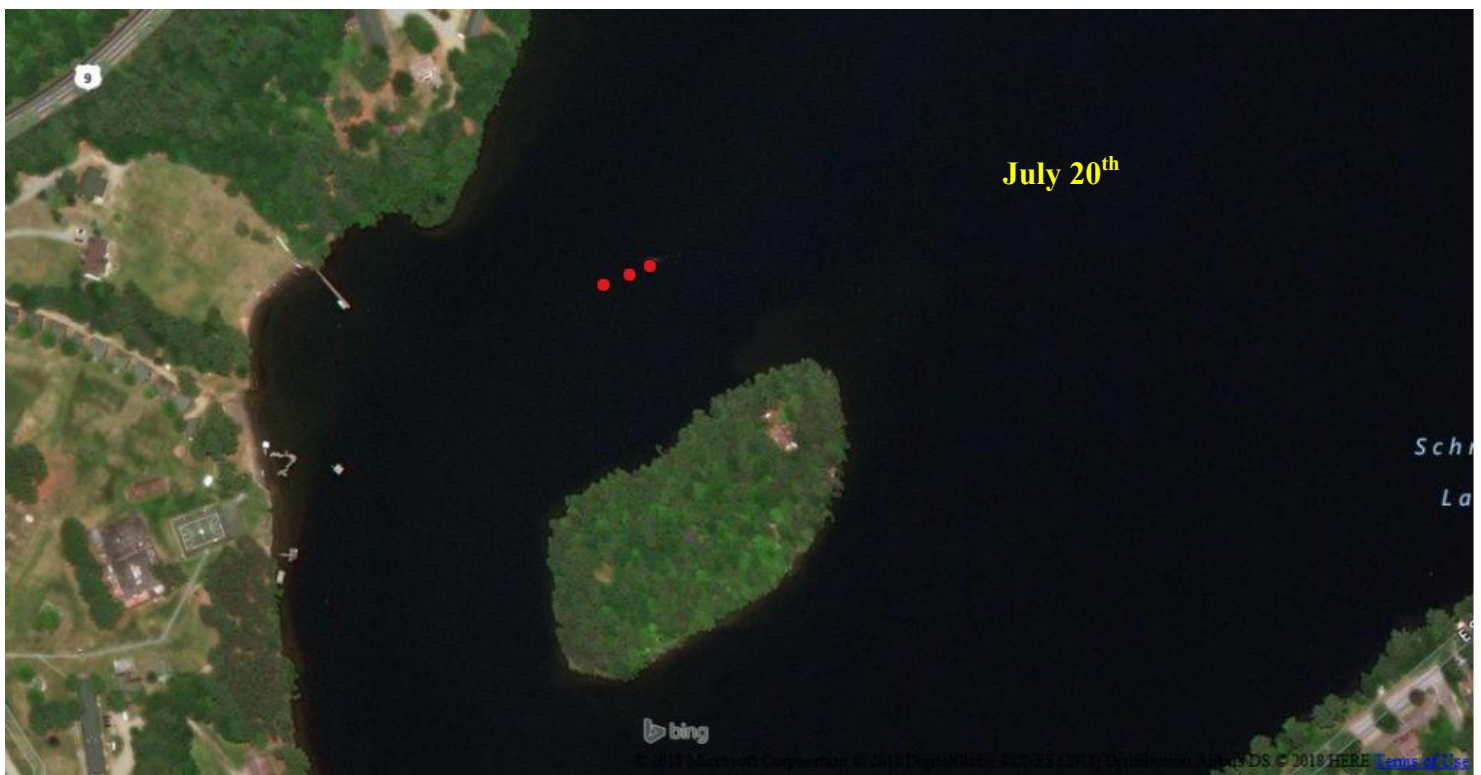
North west side of Brill Island in channel- At the three mapped GPS points, approximately 100 yards off the island, we observed a 20x100ft dense bed of mature multi-stem EWM plants in 10-12 ft water depth. This area is very rocky and smaller single stem EWM plants are growing on the perimeter of the bed in depths of 15 ft. This bed is in the channel with heavy boat traffic.

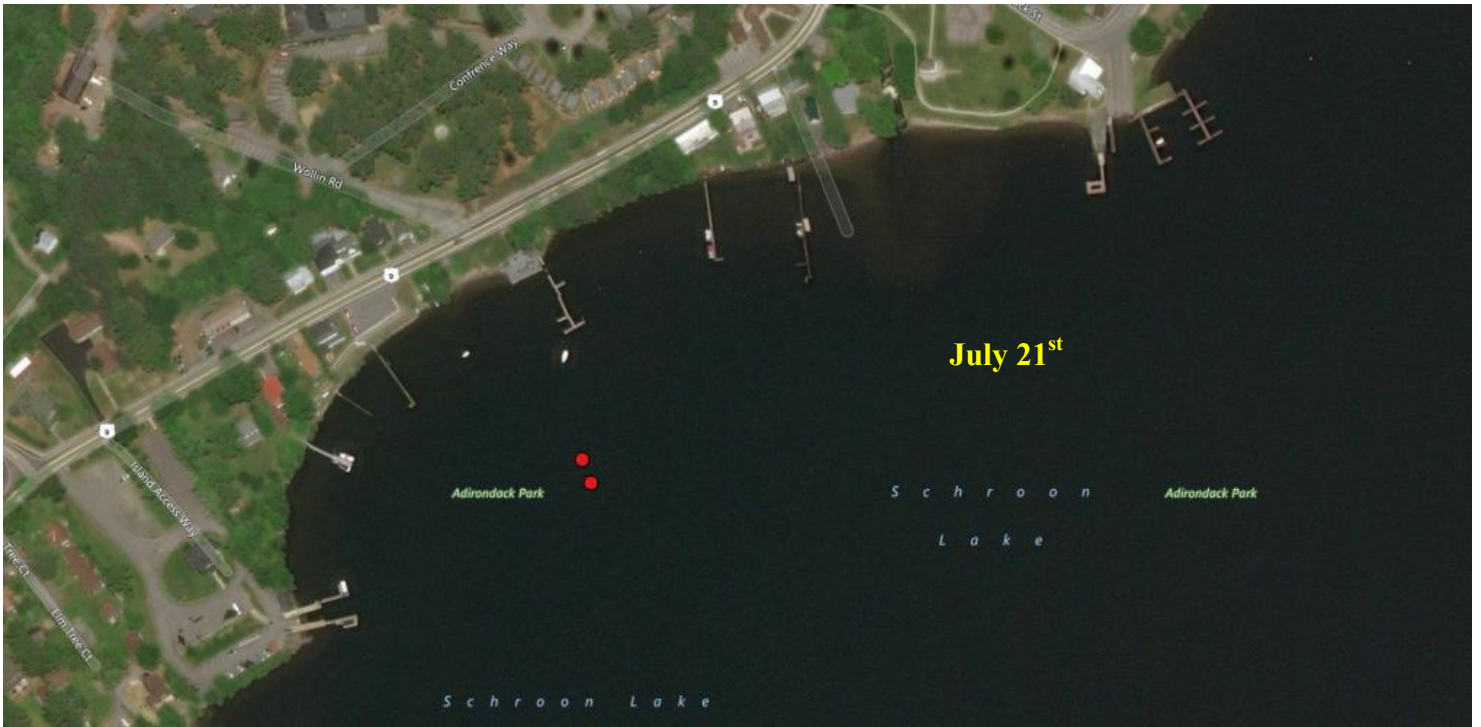
WOL Lodge- Approximately 150 yards off the gabion rock wall we have two mapped GPS locations outlining a dense bed of mature EWM plants. North of the mapped GPS points, we observed numerous scattered EWM plants for approximately 200 yards. This area has very poor visibility and native milfoil plants as well.

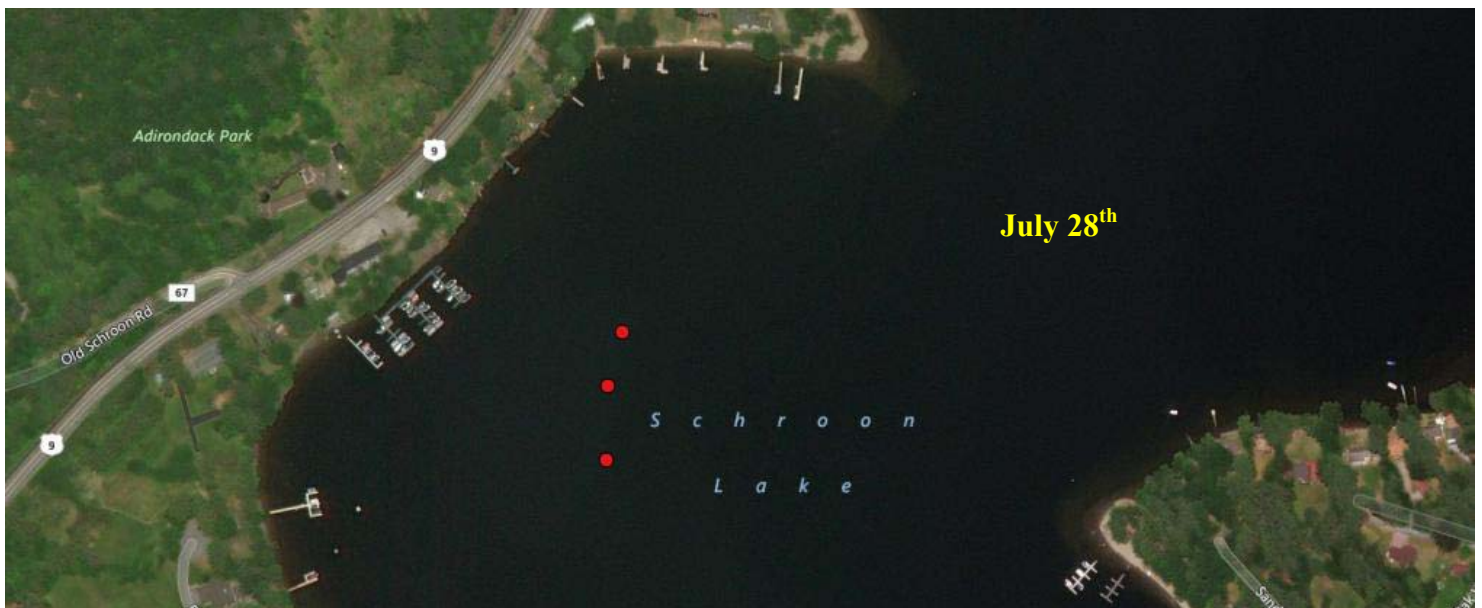
Edge Water: While there was low boat traffic, we surveyed the outside deeper parts of the bay. We observed approximately 100 widely scattered EWM plants at the three mapped GPS points in 8ft depth of water. The plants are both multi-stem and single stem younger plants. This area has very poor visibility, lush native growth with native milfoil as well. We will finish this bay during the next survey.

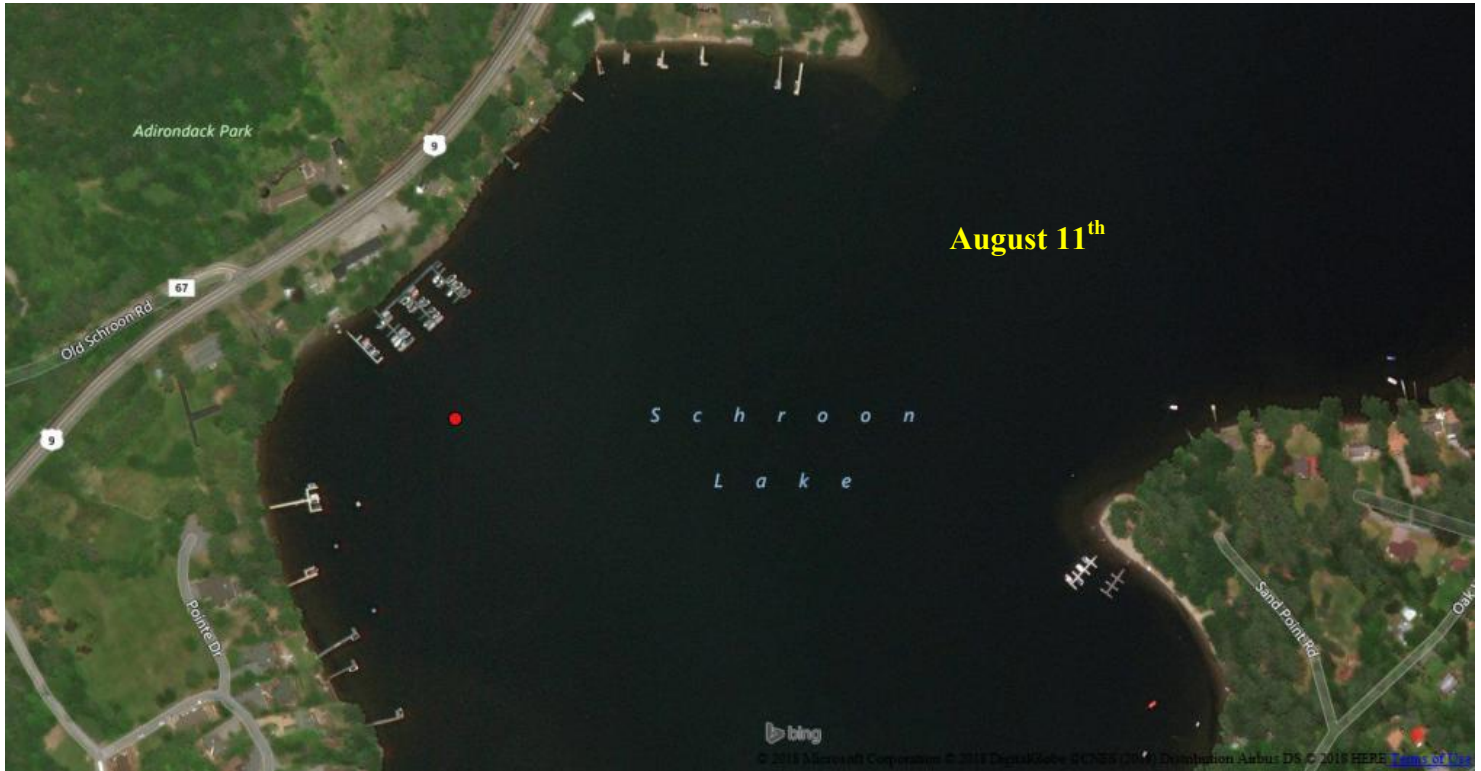
Edge Water (shallows): We finished surveying the shallow sections inside the Edge Water bay. In the attached GPS map, we observed 30-40 EWM plants in approximately 6ft depth. The EWM plants are widely scattered around the GPS point and are mostly single-stem. This area has poor visibility with tall native plants including native milfoil.

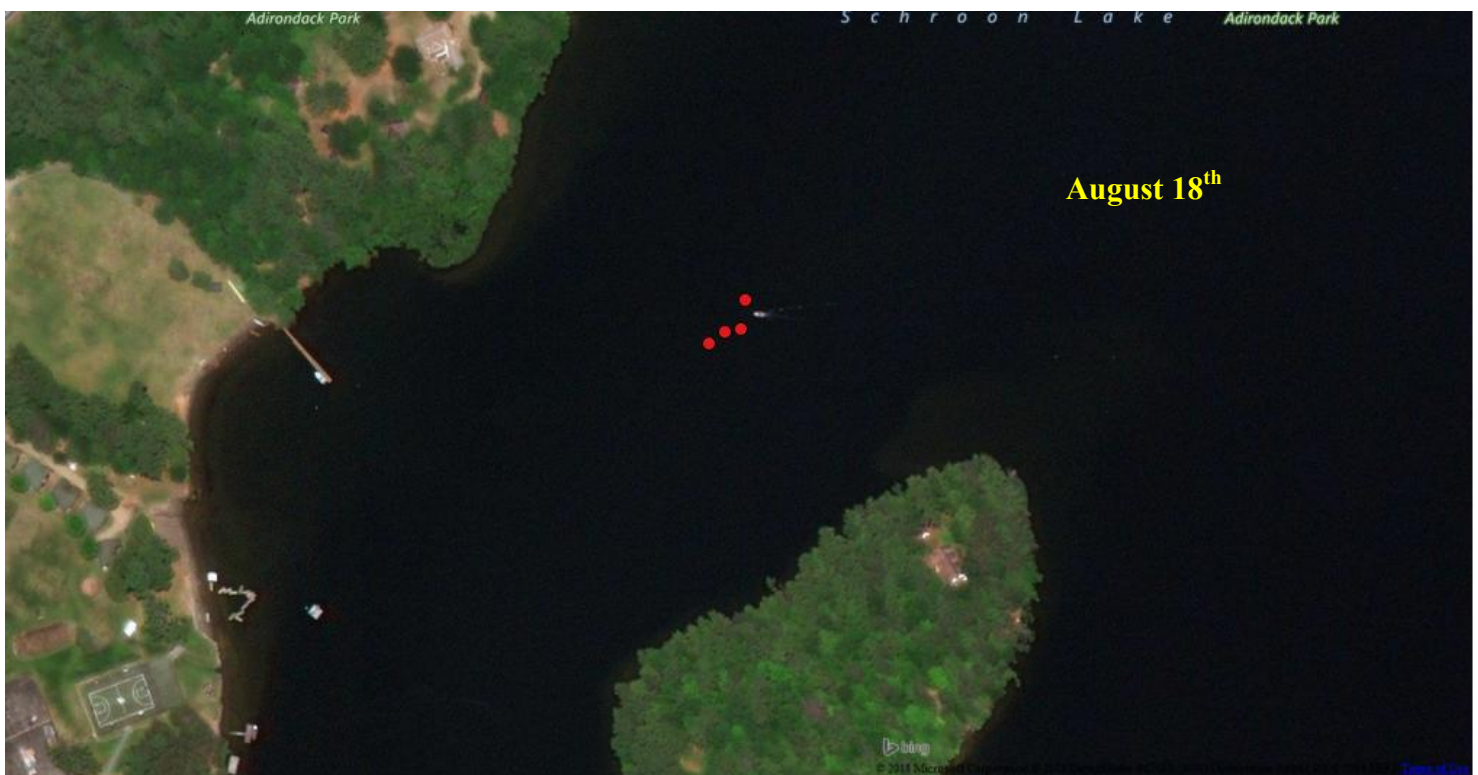
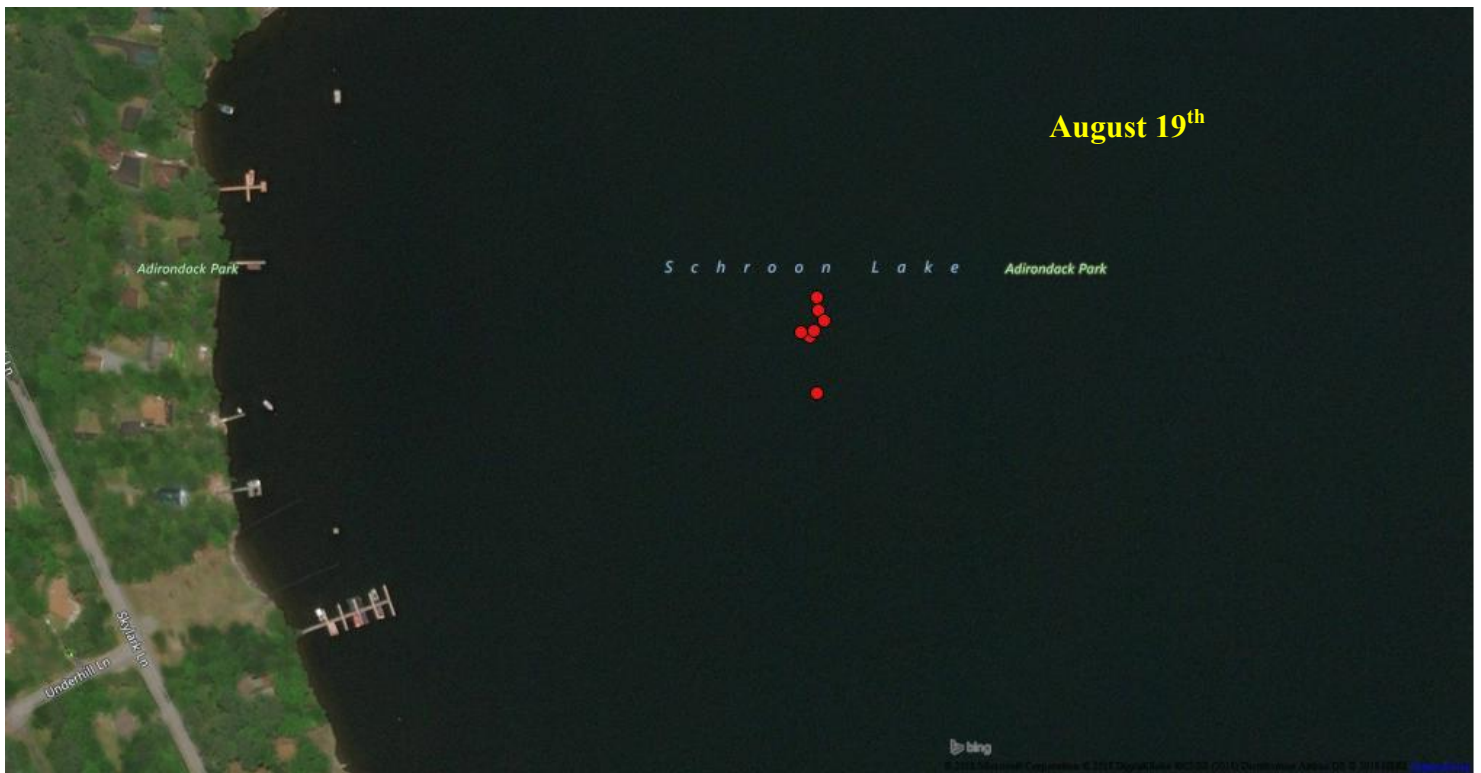
Skylark: This area has an extensive littoral zone that extends well out into the channel. At the mapped GPS points, we observed at least 200-300 scattered EWM plants approximately 400 yards from shore. The EWM is growing in 12ft depths. This area is very large with high boat traffic and will need additional surveying east of the GPS points. We took numerous GPS points following a line of scattered EWM plants. The GPS data and maps are also attached with this report.
