**Schroon Lake Invasive Species Reconnaissance 2019**  
**Robert Bombard & Nicholas Rowell**  
**21 Bluebird Road**  
**South Glens Falls, NY 12803**

The 2019 Eurasian Watermilfoil (EWM) survey of Schroon Lake is a continuation of our five year partnership with the Schroon Lake Association. The EWM survey parameters included us snorkeling and scuba diving approximately 10ft apart throughout the littoral zone of the chosen sites. The survey consisted of snorkeling the shallow areas of plant growth to scuba diving to the deepest point of plant growth. Throughout each site surveyed, the EWM plant locations were mapped using a Garmin GPS. After each survey day, a report and map of GPS EWM locations were sent to both the SLA and Invasive Solutions Dive Co., LLC. The sites surveyed were chosen through a combination of the SLA Board Members, the Lake Manager suggestions, areas with extensive littoral zones, high nutrient areas at tributary outlets and a focus on sites not yet surveyed. The following is a compilation of our daily reports, GPS EWM location maps and site descriptions.

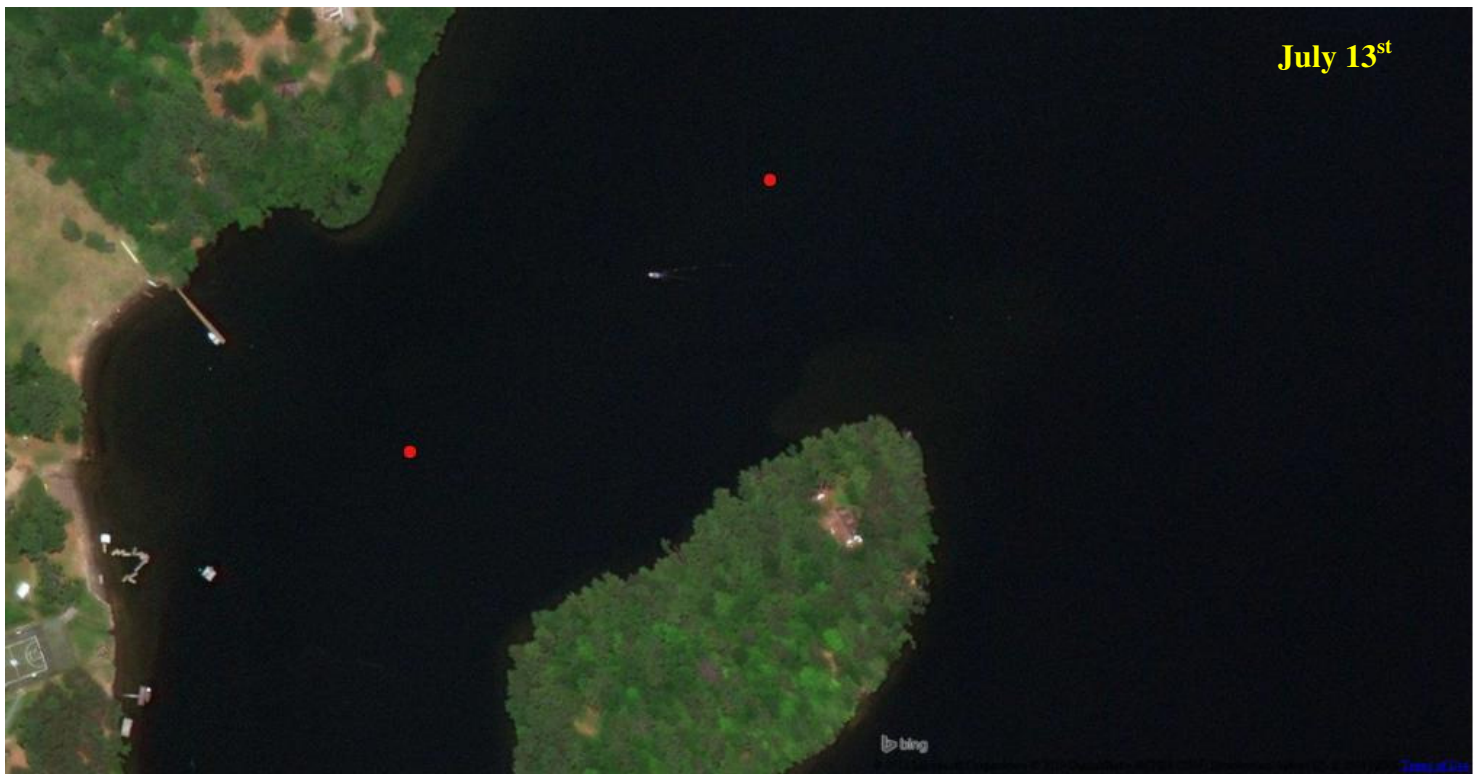
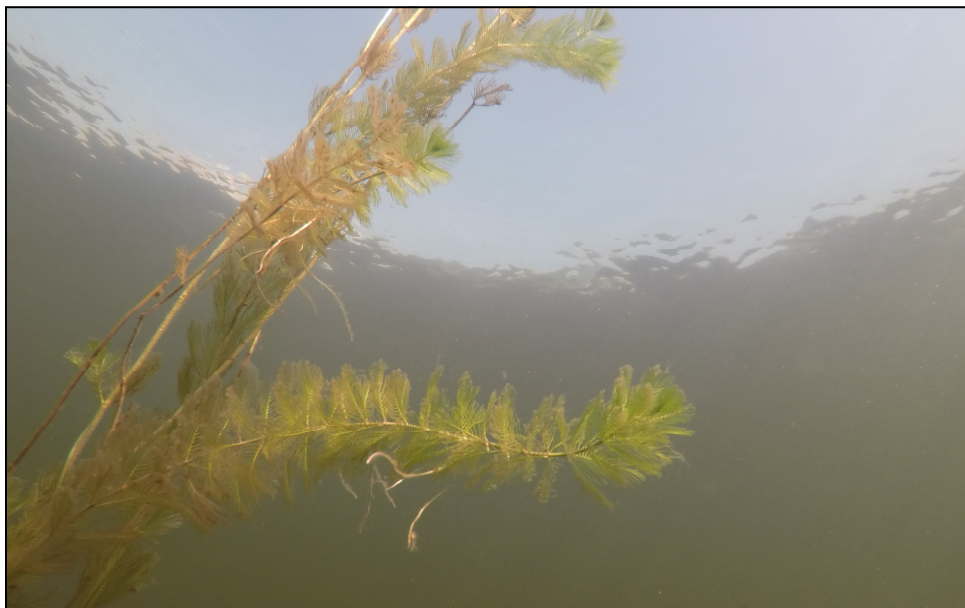
## July 13<sup>th</sup> EWM Report

**WOL Ranch-** Approximately 12 widely scattered EWM plants surveyed. This site has very lush growth with native milfoil.

**West of Brill Island-** Approximately 10 scattered EWM plants surveyed.

**North West of Brill Island-** This site was very well harvested, only 10 widely scattered EWM plants were surveyed. Last year this site was two large dense beds of EWM.

**East of WOL Island-** Only one EWM plant was surveyed. This site has very lush growth and poor visibility.

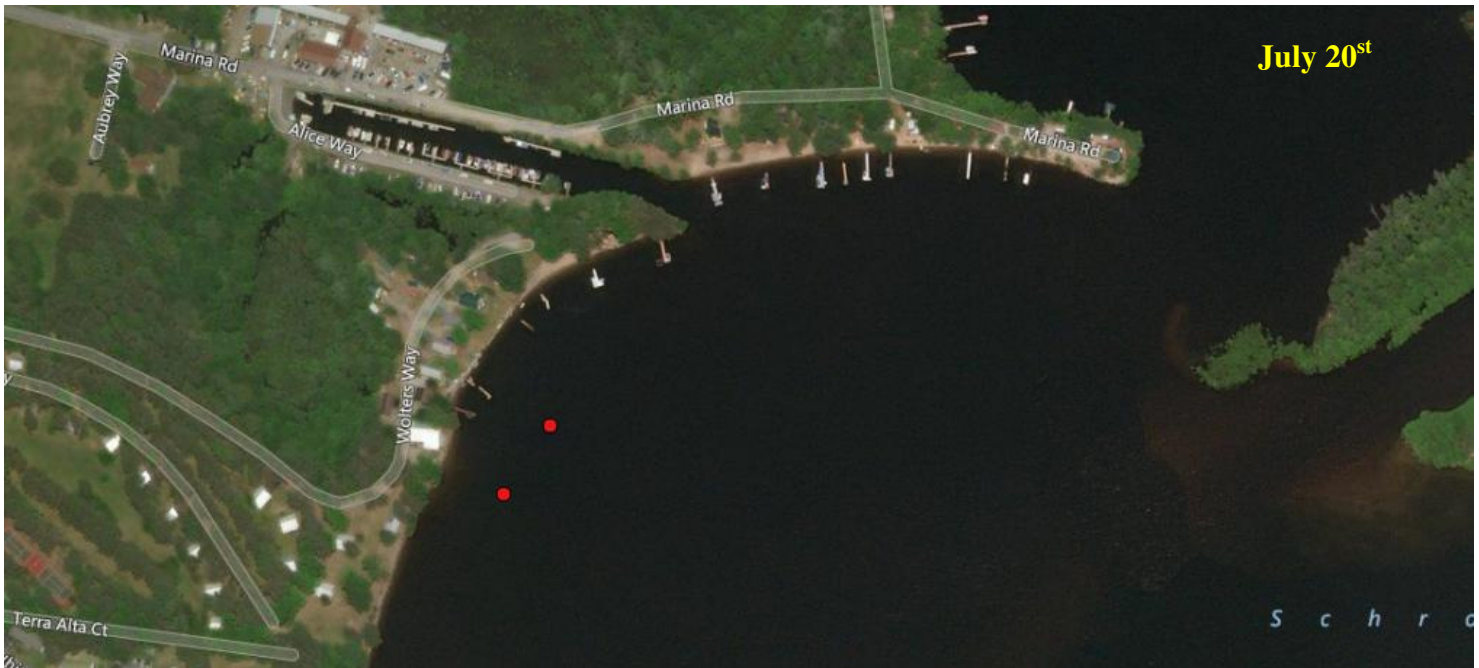
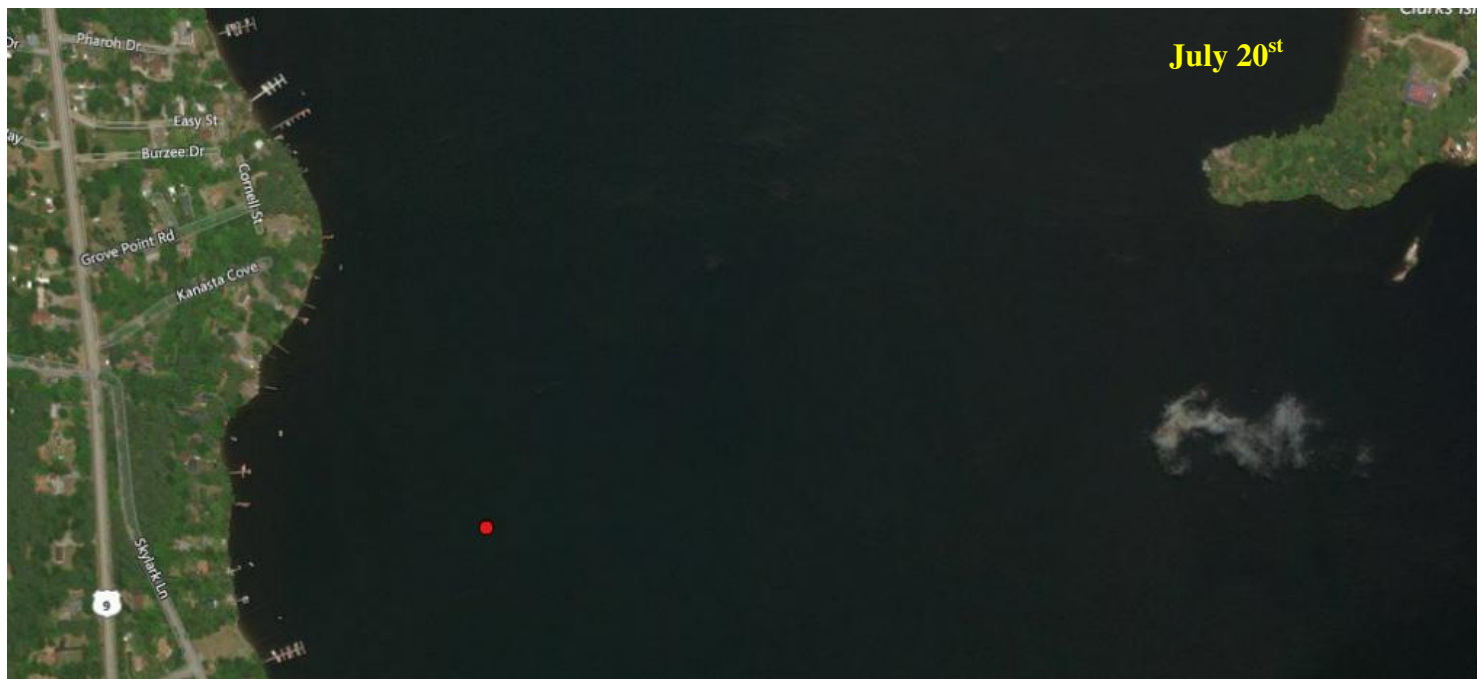
## July 20<sup>st</sup> EWM Report

**Skylark-** At the mapped GPS point in about 10ft depth, we observed approximately 200 widely scattered EWM plants in about a 50-100 meter diameter around the the GPS point. Poor visibility in this area, most of the EWM plants are single-stem and cannot be seen from the surface. This will be an interesting area to see the bathymetric mapping.

**Grove Point to Kish Duna-** Only one EWM plant observed and removed during this survey.

**Terra Alta-** At the GPS mapped south point, approximate 200 widely scattered EWM plants were observed. At the GPS mapped north point (other side of swim area), 20-30 mature multistem EWM plants were observed. This area also has a significant amount of native milfoil as well.

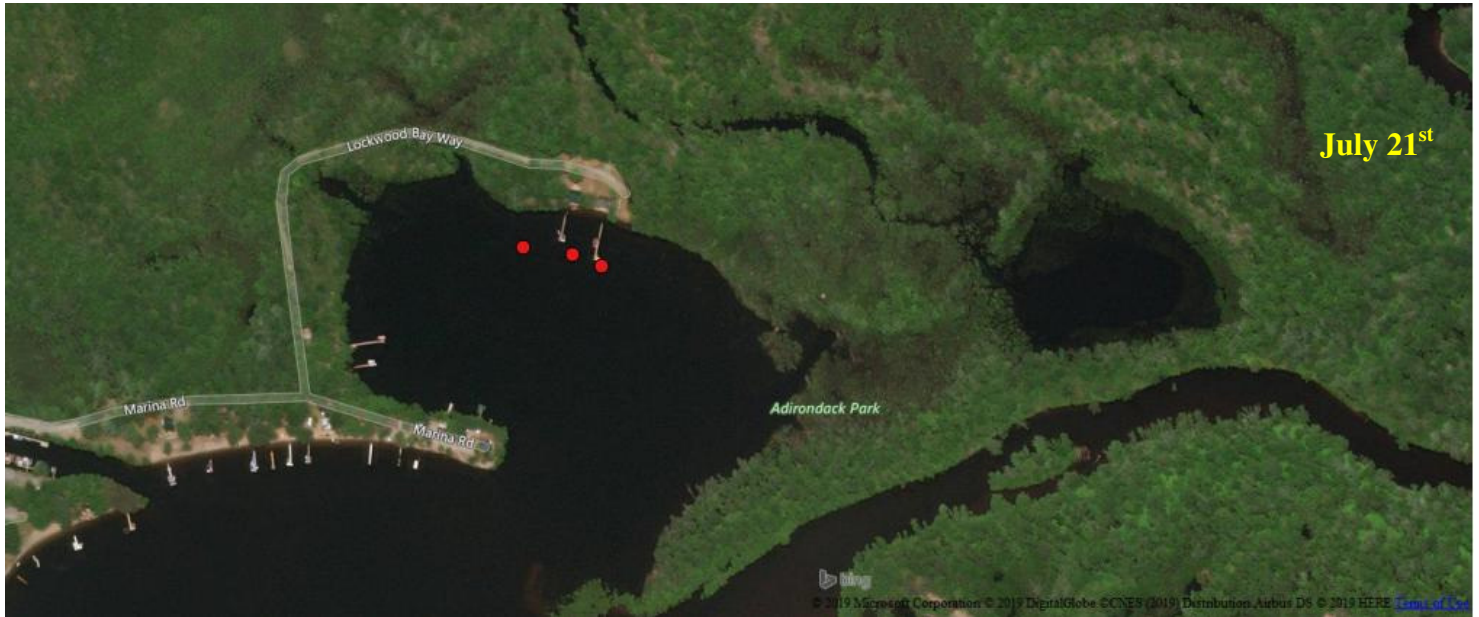
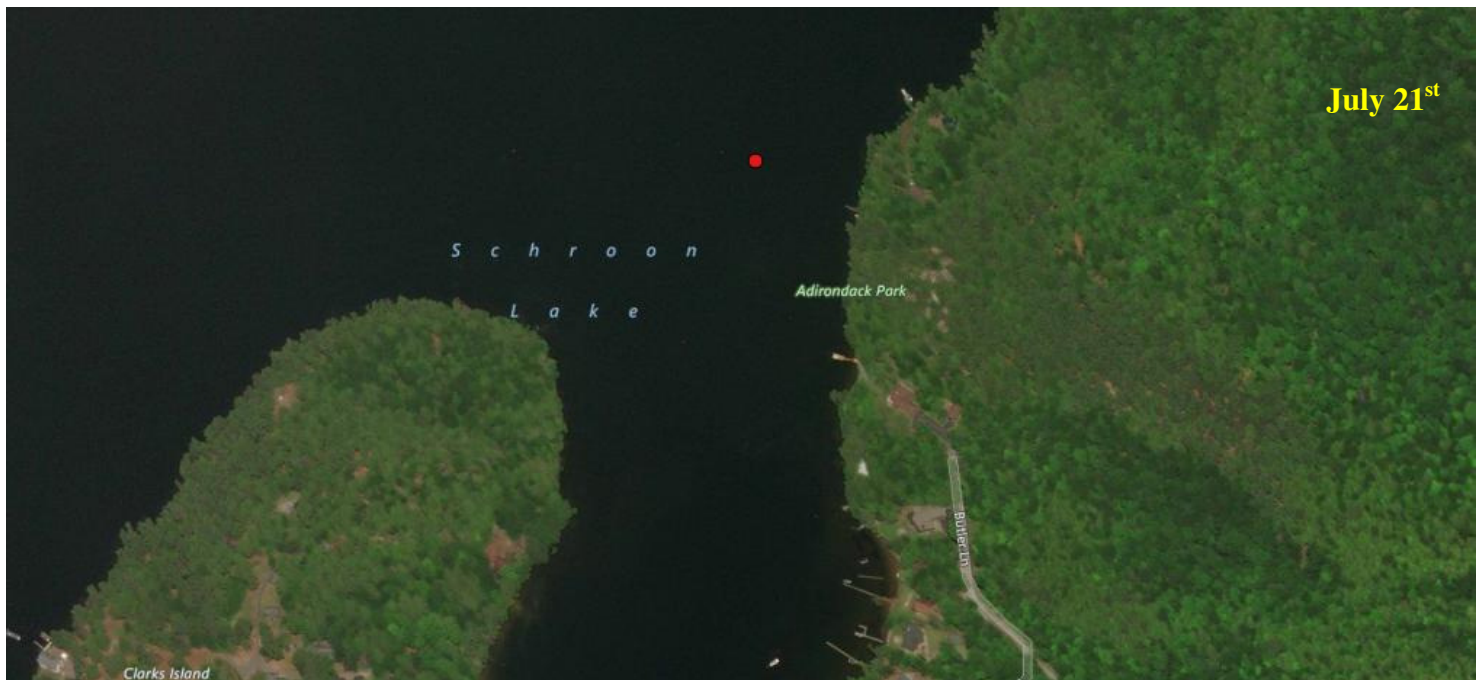
## July 21<sup>st</sup> EWM Report

**Lockwood Bay-** Widely scattered EWM on the north shore around the two mapped GPS points near the tan/yellow house. Only two EWM plants were observed on the southwest side of the bay. This area also has significant native milfoil.

**East Shore South of Talichita Point-** Approximately 50 EWM plants were observed widely scattered at the mapped GPS point. The GPS point is inline with the danger buoys and the plants cannot be seen from the surface with low visibility in the area.

**South End of Clark Island-** No EWM plants were observed during the survey.

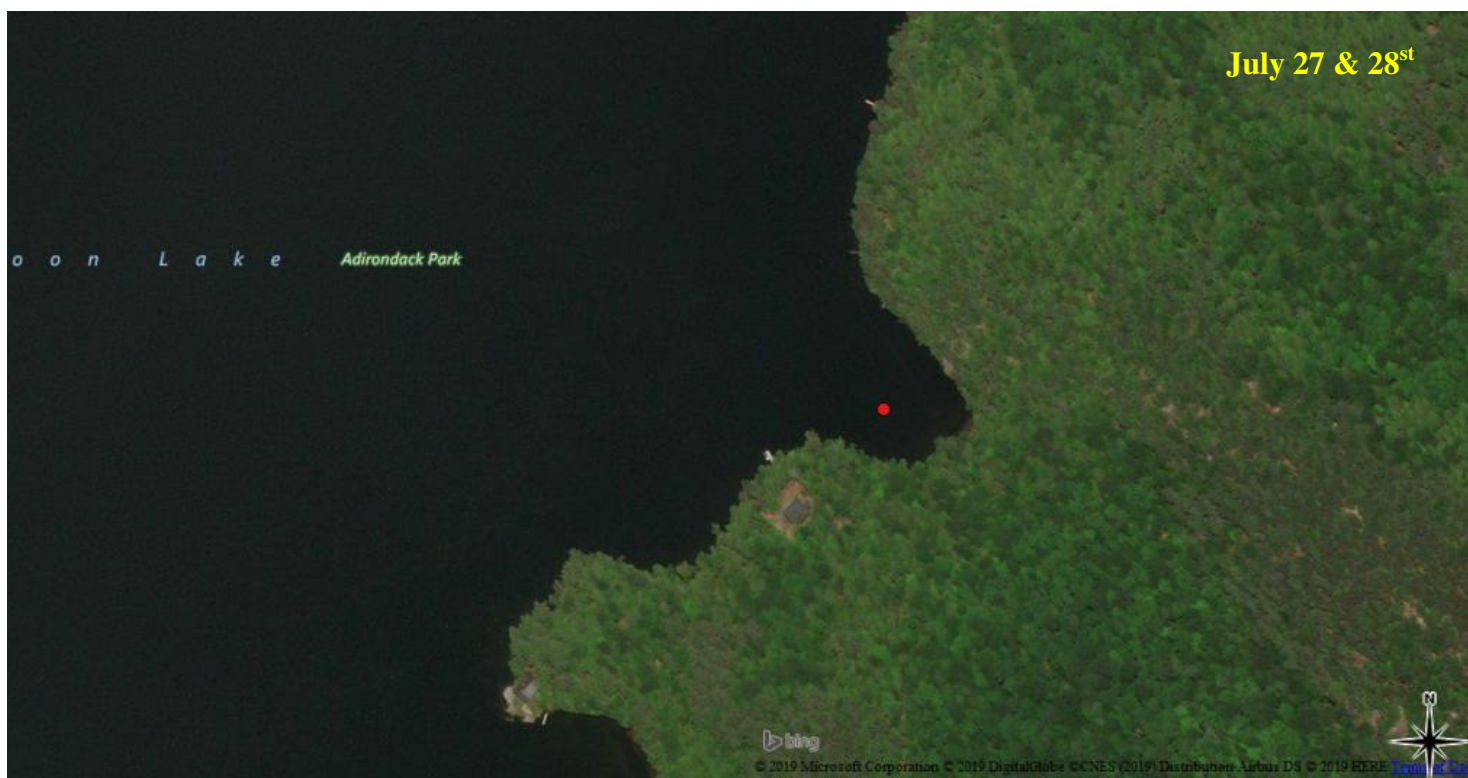
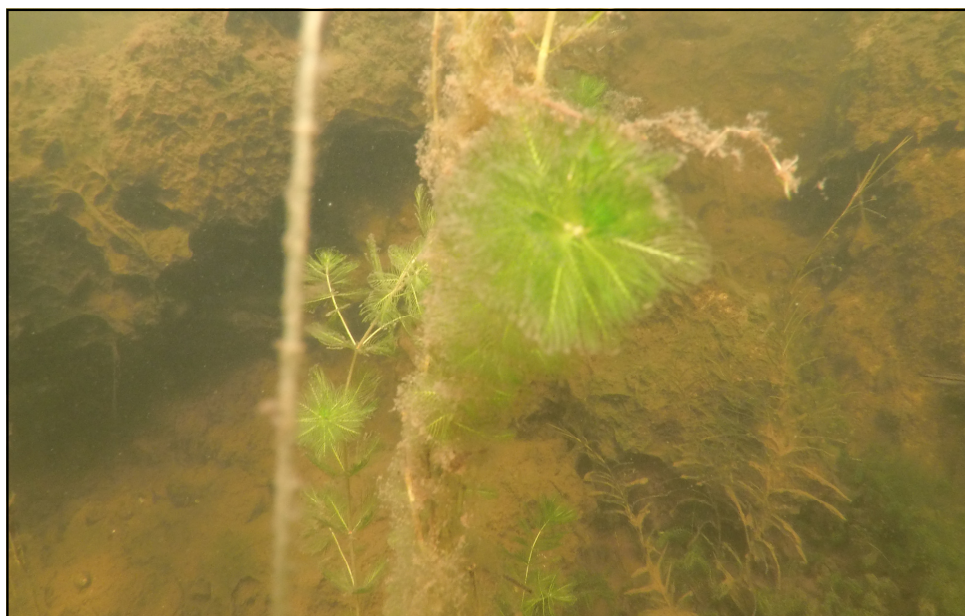
## July 27<sup>th</sup> & 28<sup>th</sup> EWM Report

**Steep Bay North & South-** At the GPS mapped location, 15-20 EWM plants were observed. 10 very widely scattered EWM plants were removed during the survey.

**Talichita South Bay-** No EWM plants were observed during the survey.

**Taylor Point, Moffit Brook, Acker Brook North-** 5 large multi-stem EWM plants were removed during the survey near Moffit Brook.

**Thurman Pond Outlet North Side-** We only had time to survey the north section and no EWM was observed.

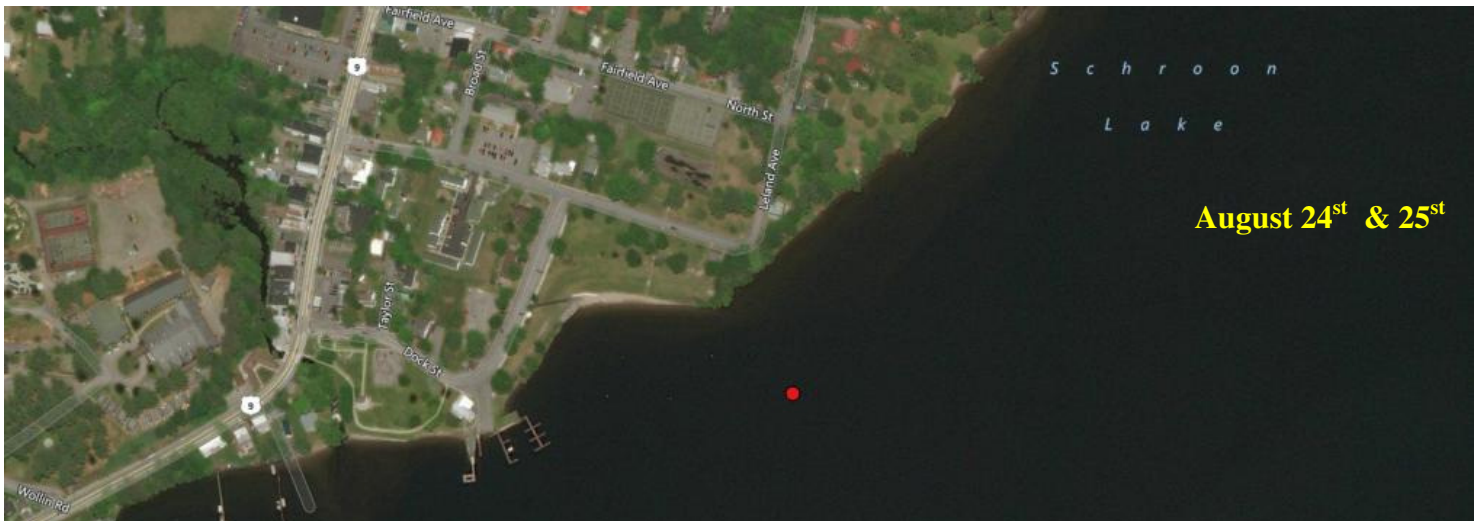
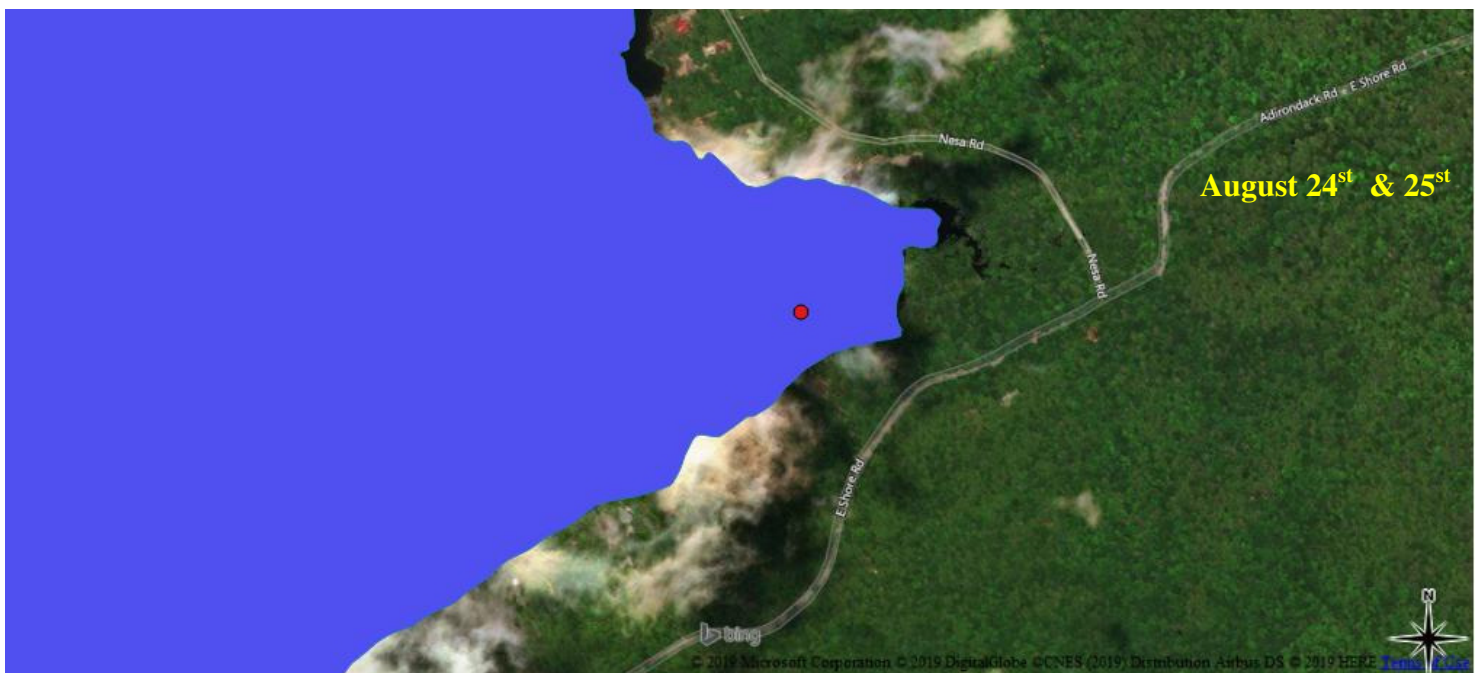
## August 24<sup>th</sup> & 25<sup>th</sup> EWM Report

**Meadow Cove-** Removed 15 very widely scattered single-stem EWM plants. This area has lush growth and the EWM population is very low compared to past years.

**South of Meadow Cove-** No EWM was observed during the survey.

**Ocker Property-** The bed of plants near the property dock are P. Gramineus. No EWM was observed during the survey north and south of this location.

**North of Town Beach & South of Keplers Point-** At the mapped GPS point is a danger buoy with approximately 15 EWM plants. A few widely scattered EWM plants were removed around the large rock. North and south of this area has very limited plant growth.

**Devil's Rock-** This is a very unique area with a great diversity of native plants. No EWM was observed during the survey. This is an important area to watch over due to the mid lake location with a lot of boat traffic.
